TS-AMD-83056e
November 1984

AERIAL PHOTOGRAPHIC ANALYSIS OF WASTE STUDY SITES

Montana

AERIAL PHOTOGRAPHIC ANALYSIS
WASTE STUDY SITES

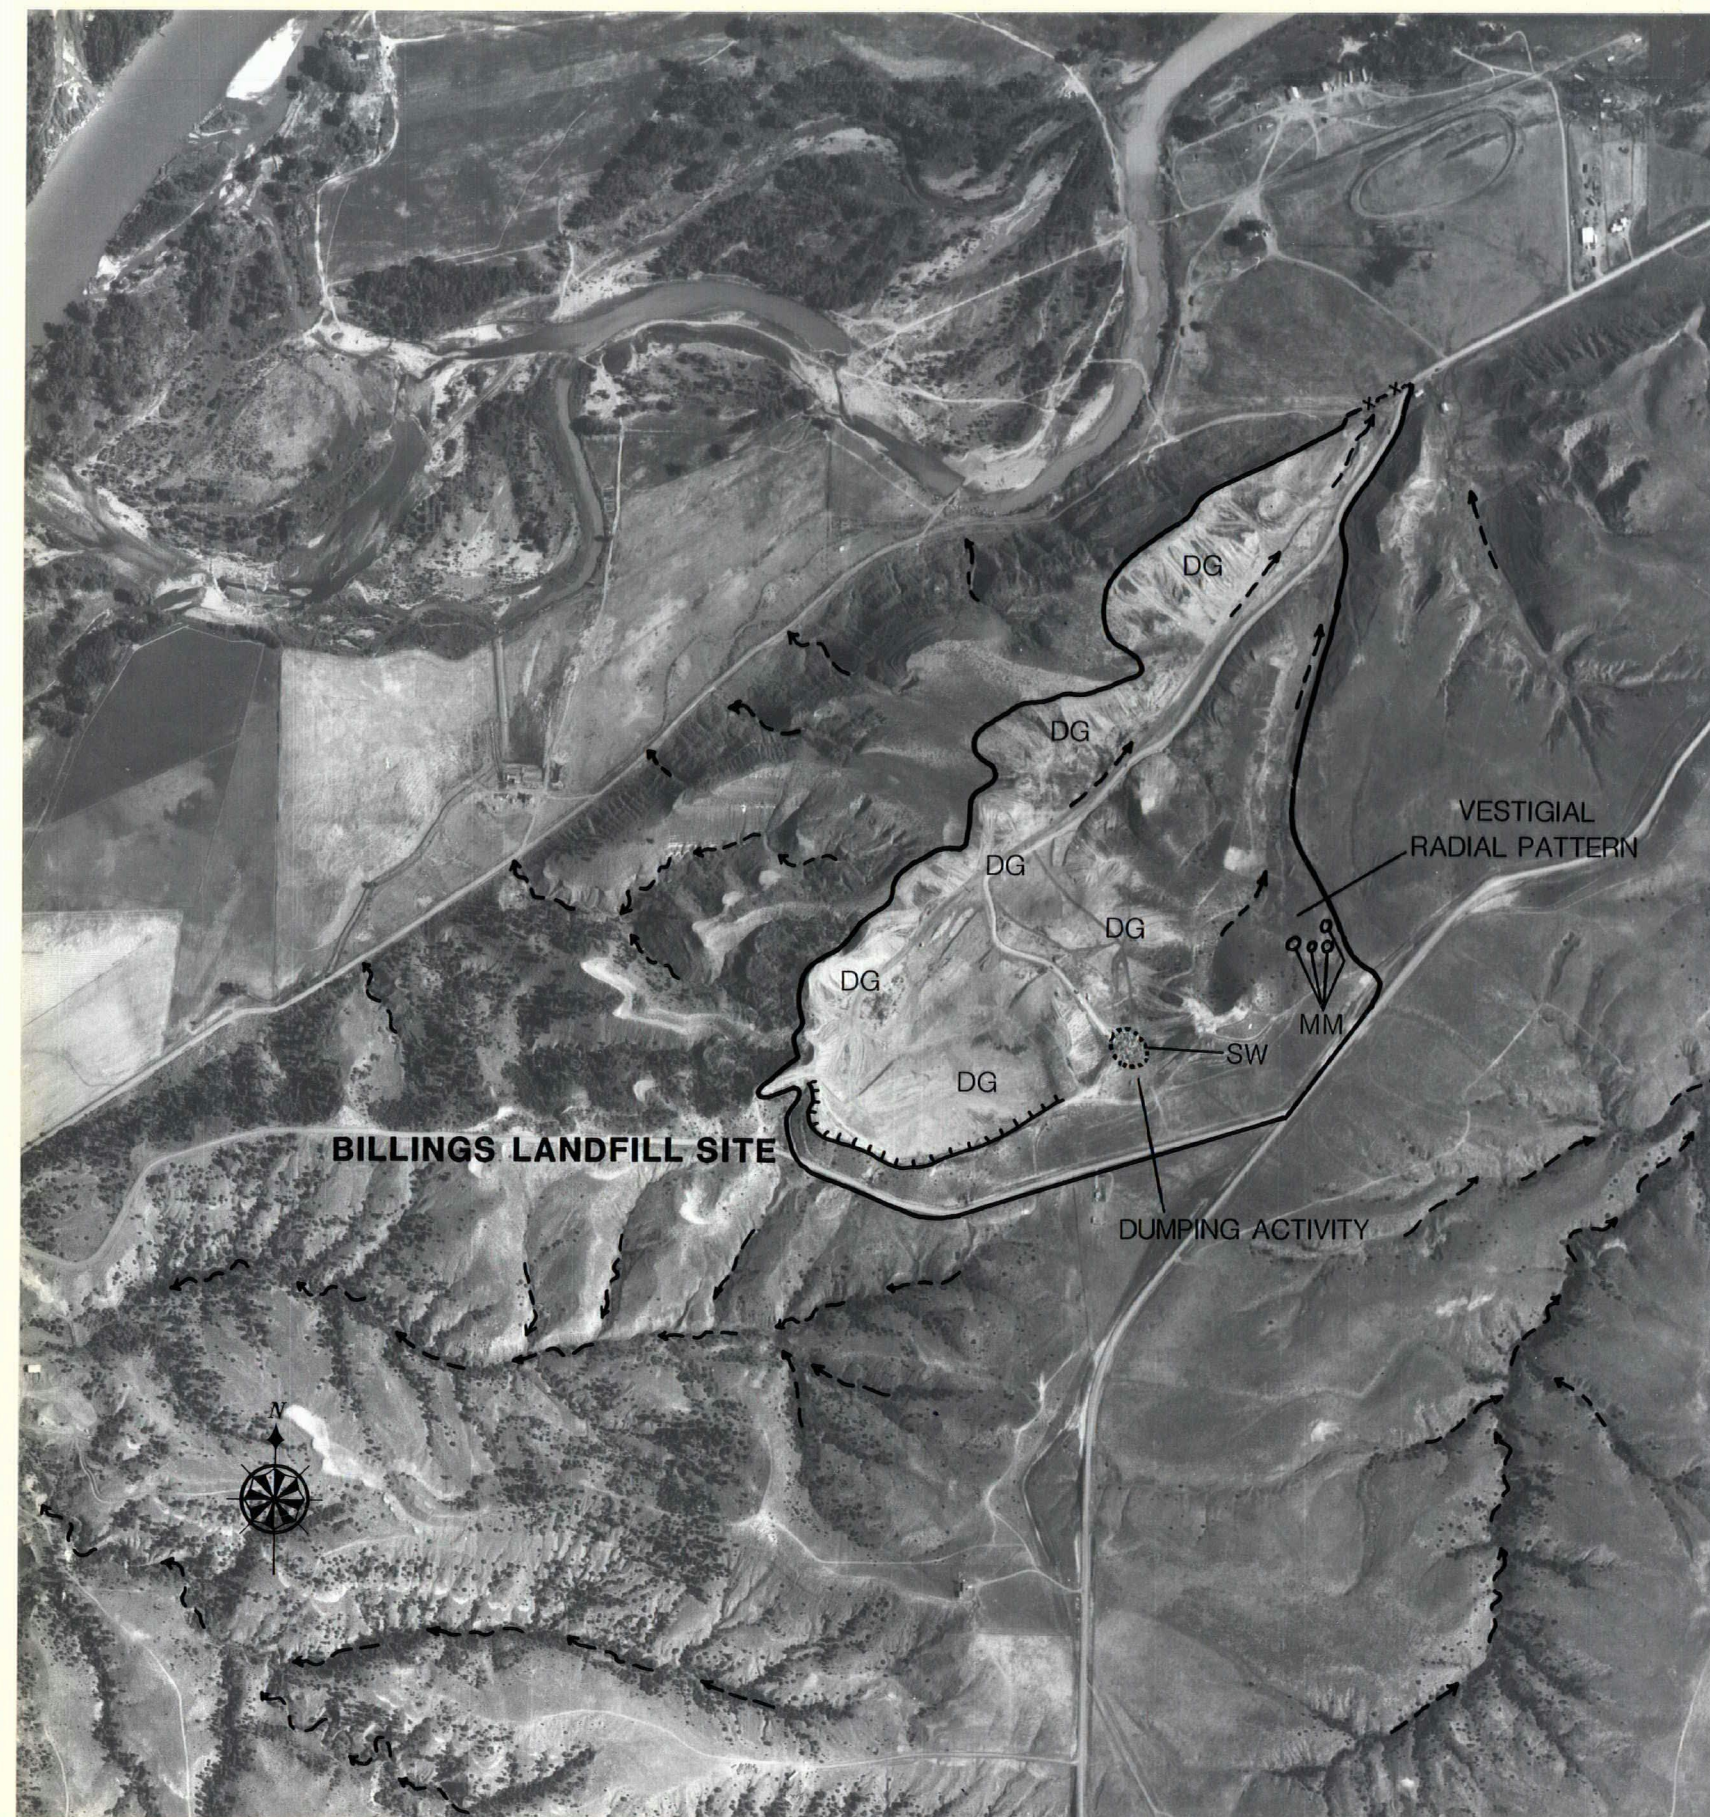
Figure 24 shows that waste disposal activity at the site appears to have decreased since 1966. Solid waste is only visible in one location. A canyon previously included in the northeast corner of the site where solid waste was observed in 1966 shows no sign of waste disposal activity or solid waste. Traces of the radial trench pattern visible in 1966 are still present, along with the mounds. No activity is evident at this location. Extensive areas of disturbed ground are still evident throughout the site. Two fences visible in 1966 are no longer present.

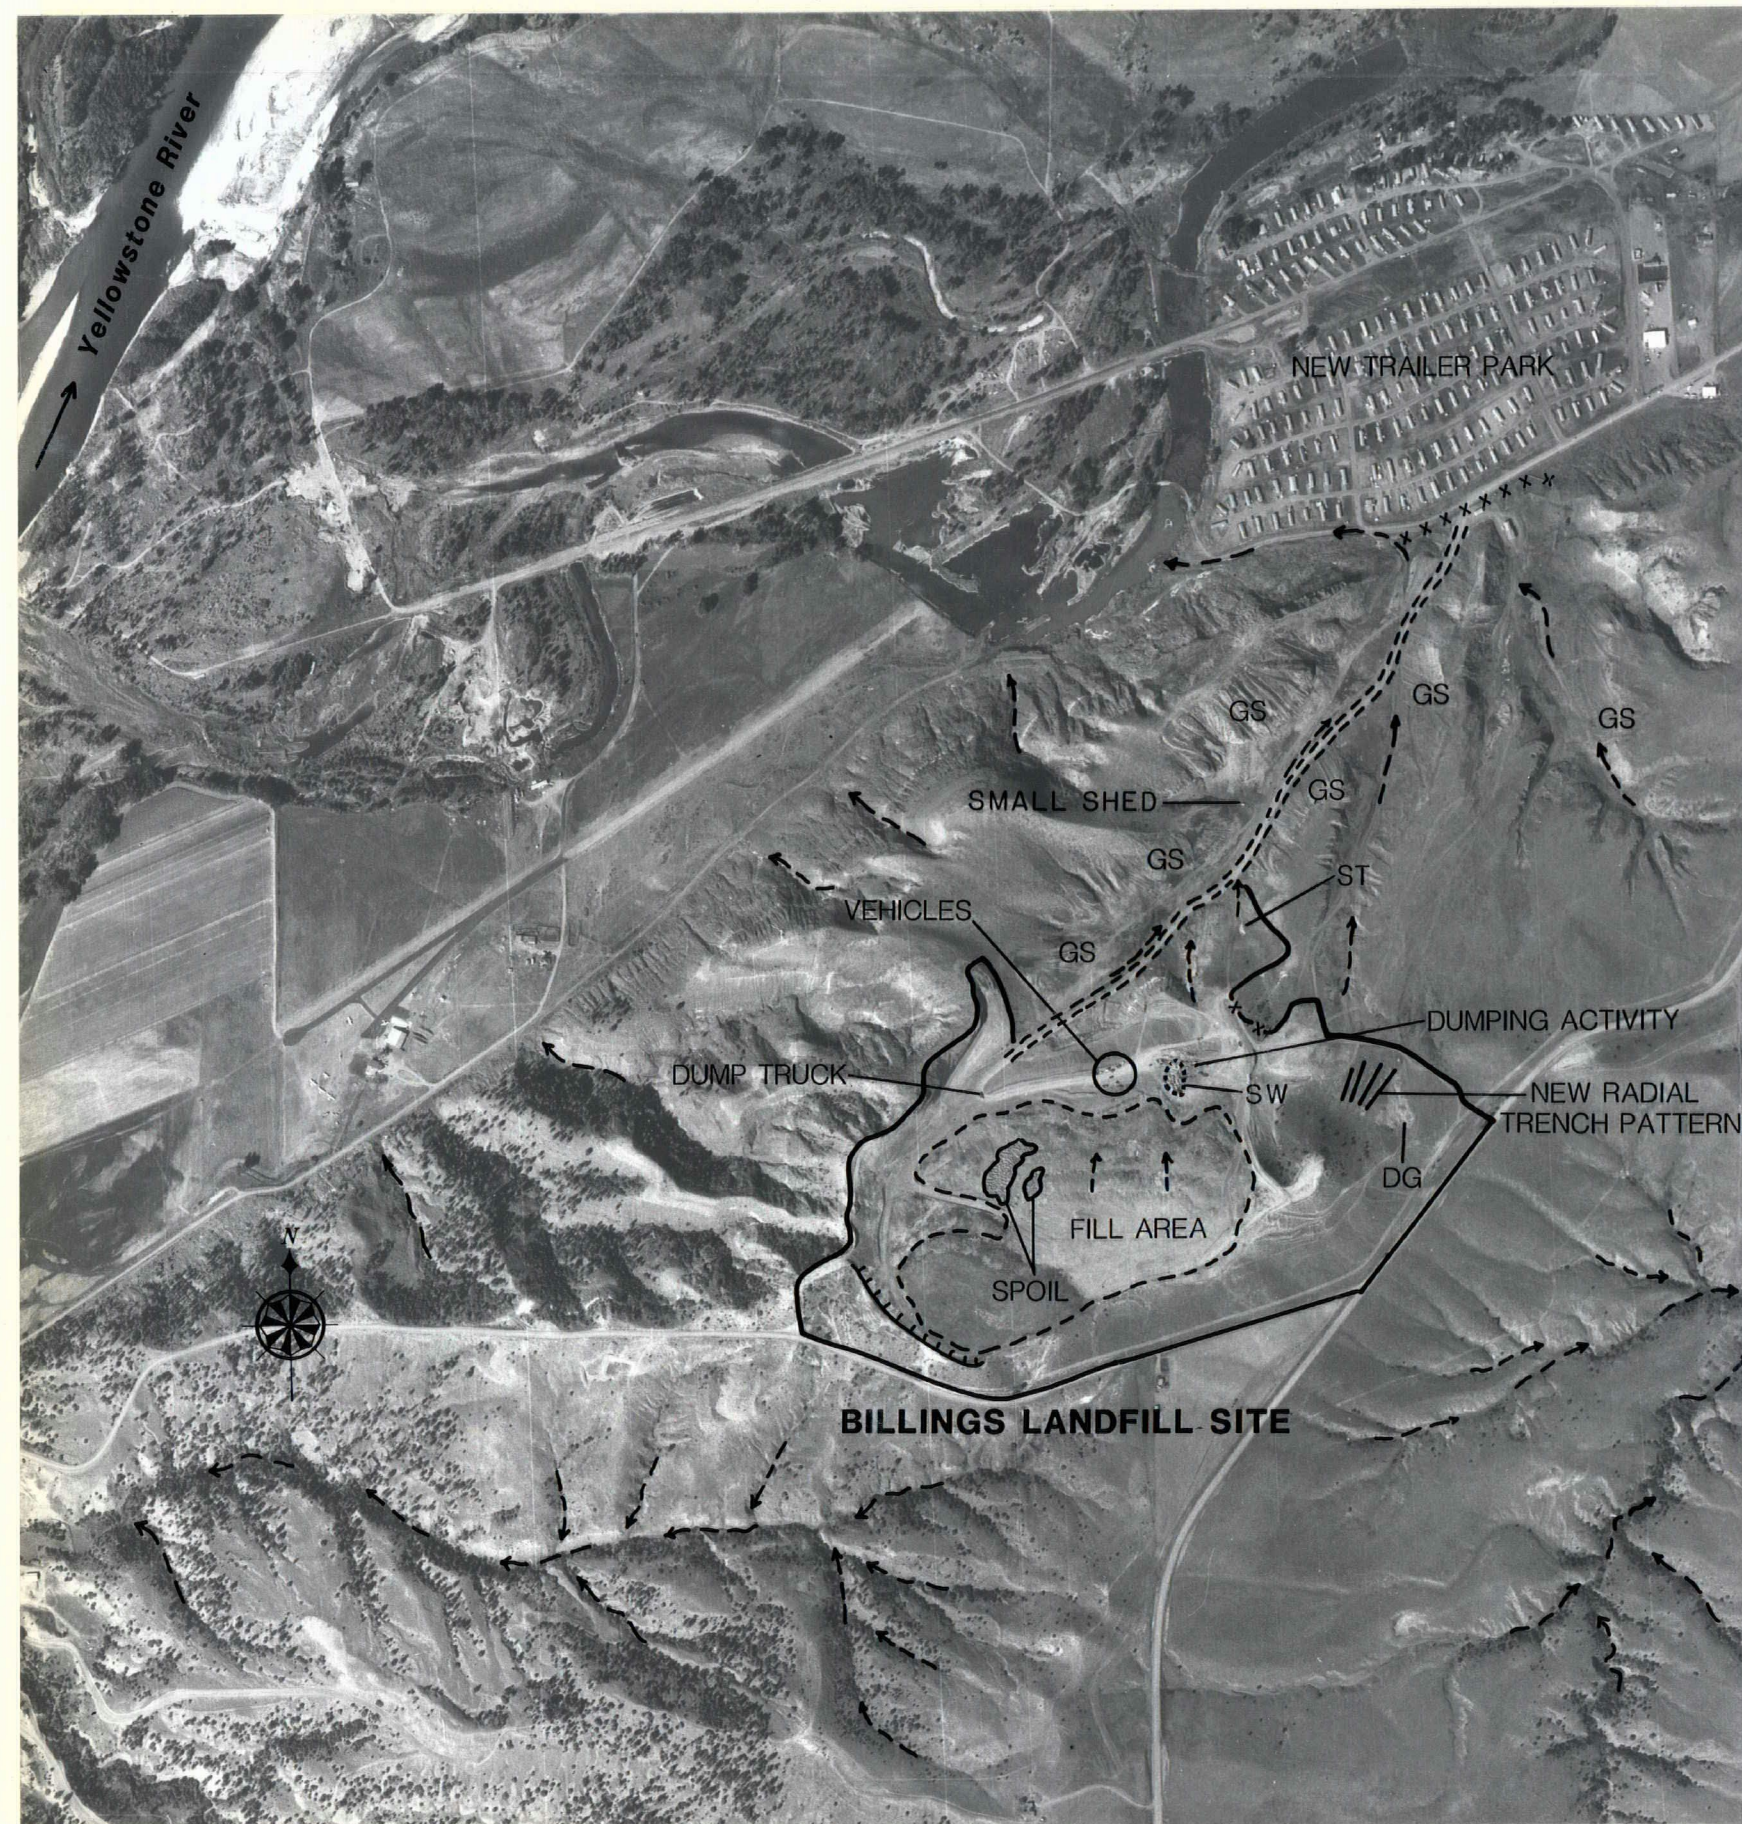
Figure 25. Billings Landfill site, September 14, 1979. Approximate scale 1:12,000.

Figure 25 shows that significant changes have occurred at the site since 1972. Solid waste disposal can still be observed in an area north of where it was observed in 1972. An extensive fill area now occupies a large portion of the site. The place where waste disposal was observed in 1972 has now been covered by this fill material; solid waste seems to be intermixed with this material as a result of burial activity. Two large concentrations of spoil or fill material are present on the landfill surface. The disturbed ground and ground scarring observed along the walls of the canyon are probably the result of obtaining the fill material for use in waste burial. Four new small trenches have been dug in a new radial pattern on the east side of the site. An area of disturbed ground is also located nearby. No waste disposal is visible in this area. A small white-toned stain can be seen in the northern part of the site. The nature of the stain is not apparent.

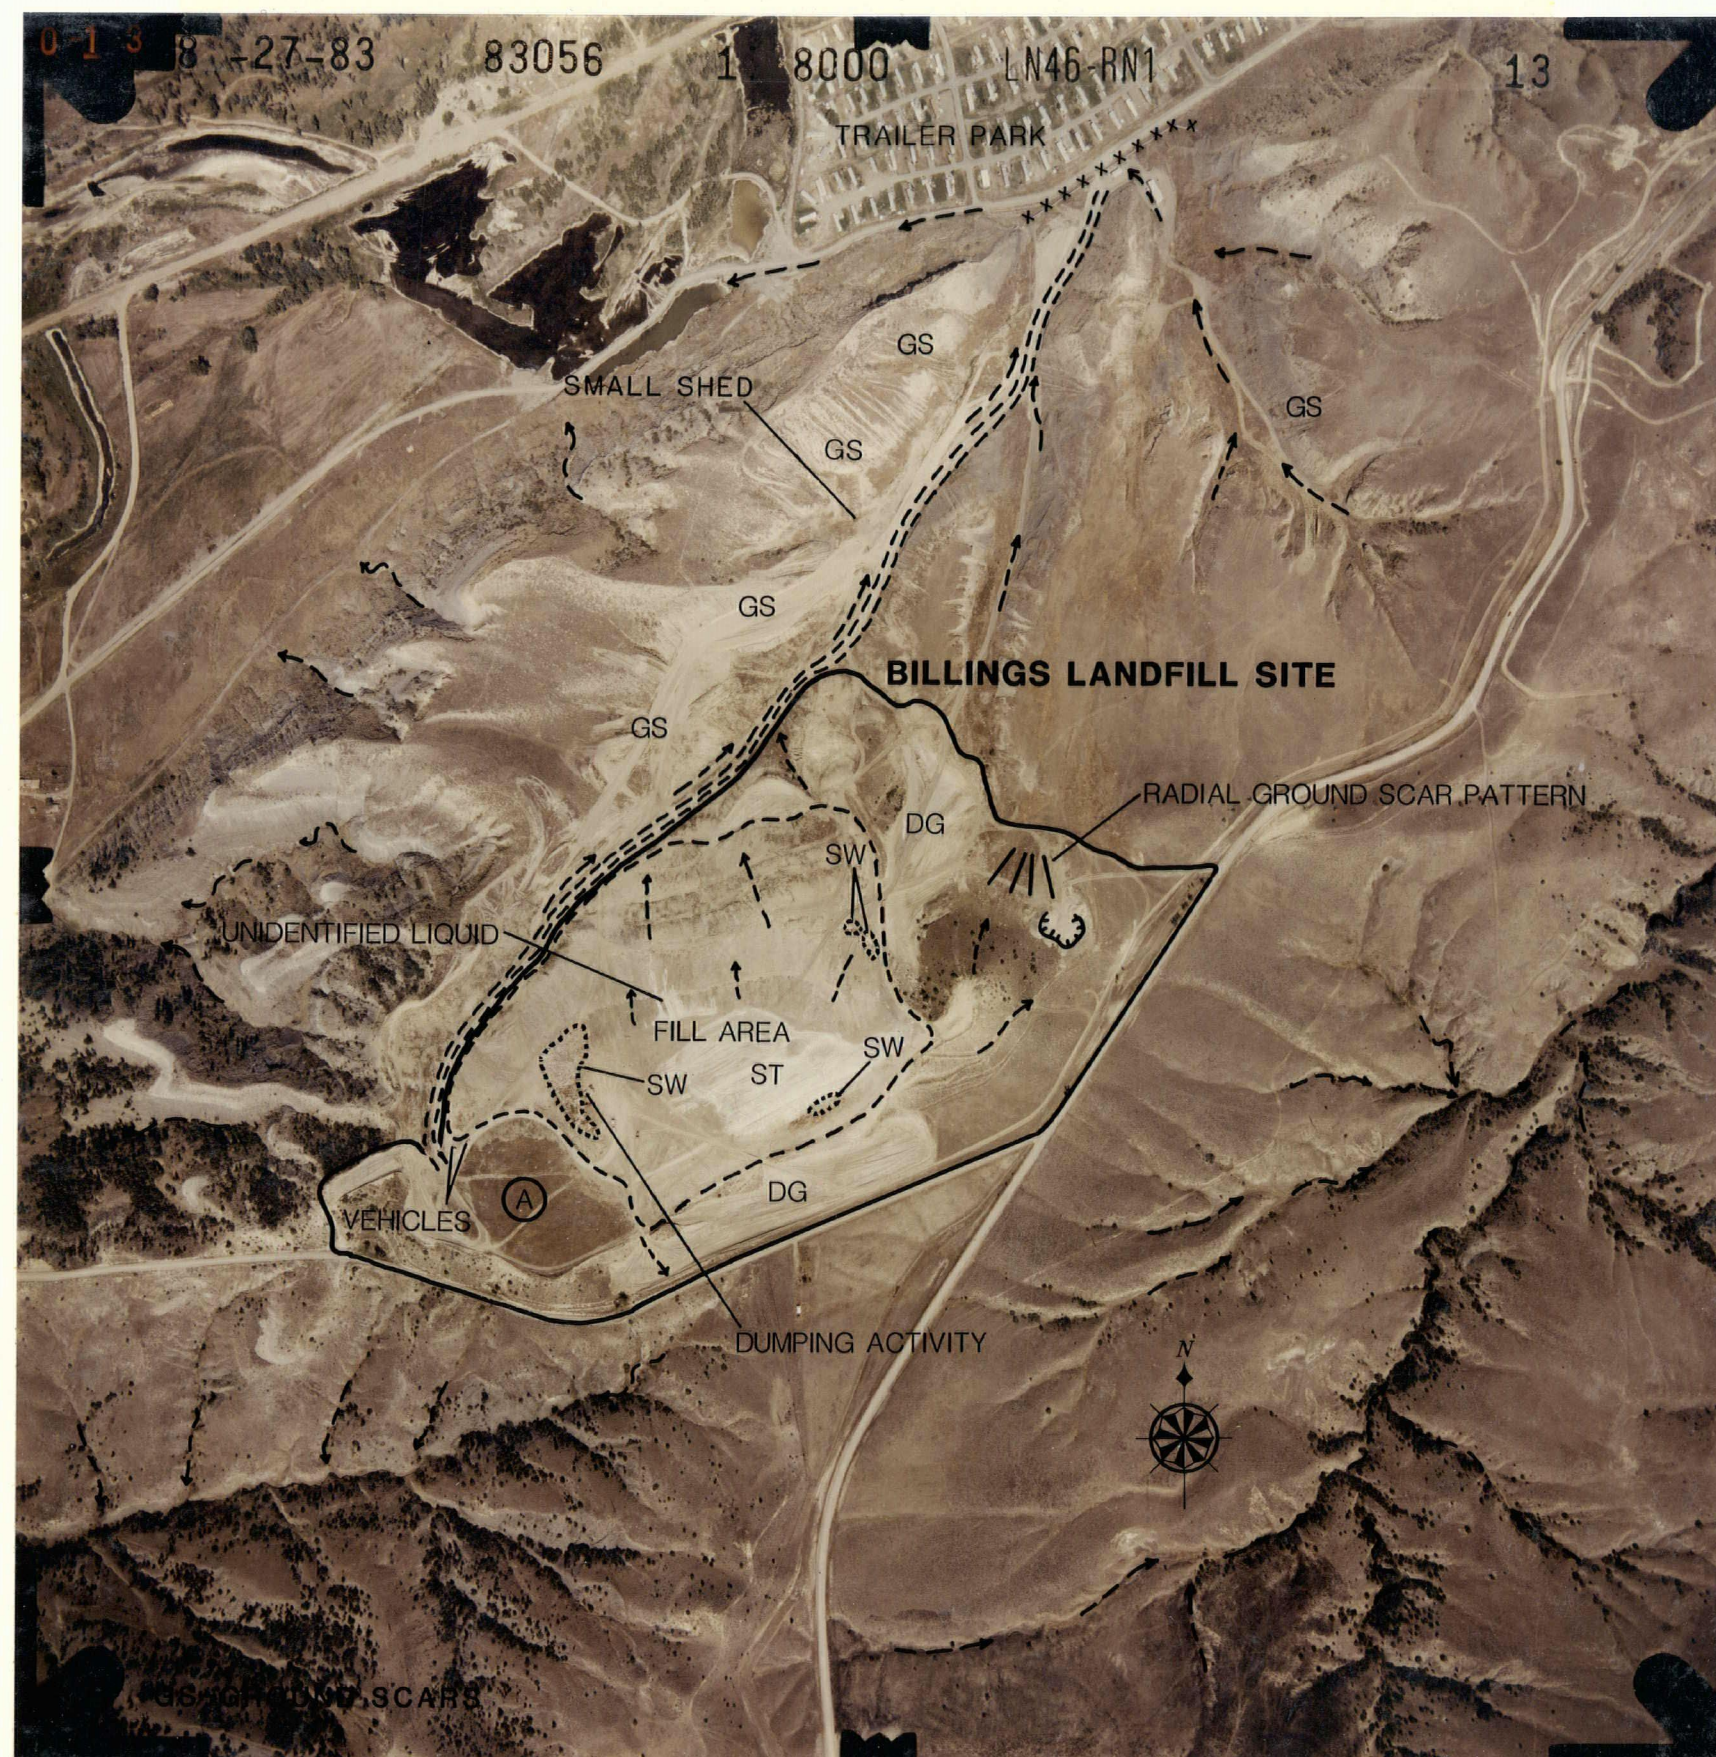
The color photograph (Figure 26) shows that the landfill area has increased in size since 1979. A large amount of solid waste is visible where dumping activity is currently underway. A bulldozer and other earthmoving vehicles are present. Solid waste is also visible in smaller concentrations at two other locations. An unidentified white liquid can be seen flowing down the outboard face of the landfill. An extensive white stain is also visible on the top of the fill. The white liquid has its origin at the top of the landfill and appears to be the result of liquid waste disposal rather than leaching, as does the white stain. A new radial ground scar pattern can be seen where trenches have previously been located. A small excavation is now associated with this pattern. No waste disposal activity is present in this area. Two new areas of disturbed ground are present at the site. No solid waste is visible at the southern area; however, solid waste appears throughout the northern area where burial may have taken place. In the southwest corner of the site a section of the landfill surface has been revegetated (Annotation "A"); however, this vegetation appears to be dead or dormant.
